HNF-EP-0182 Revision 337

Waste Tank Summary Report for Month Ending January 31, 2016

Prepared for the U.S. Department of Energy Assistant Secretary for Environmental Management

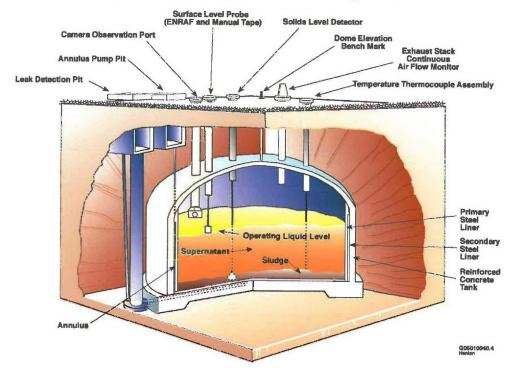
Figure 1-1. Double-Shell Tank Configuration

Illustrations of the double-shell tank (DST) and single-shell tank (SST) configurations are shown in Figure 1-1 and Figure 1-2, respectively. Figure 1-3 and Figure 1-4 summarize the 200 East Area and 200 West Area tank contents by tank farm.

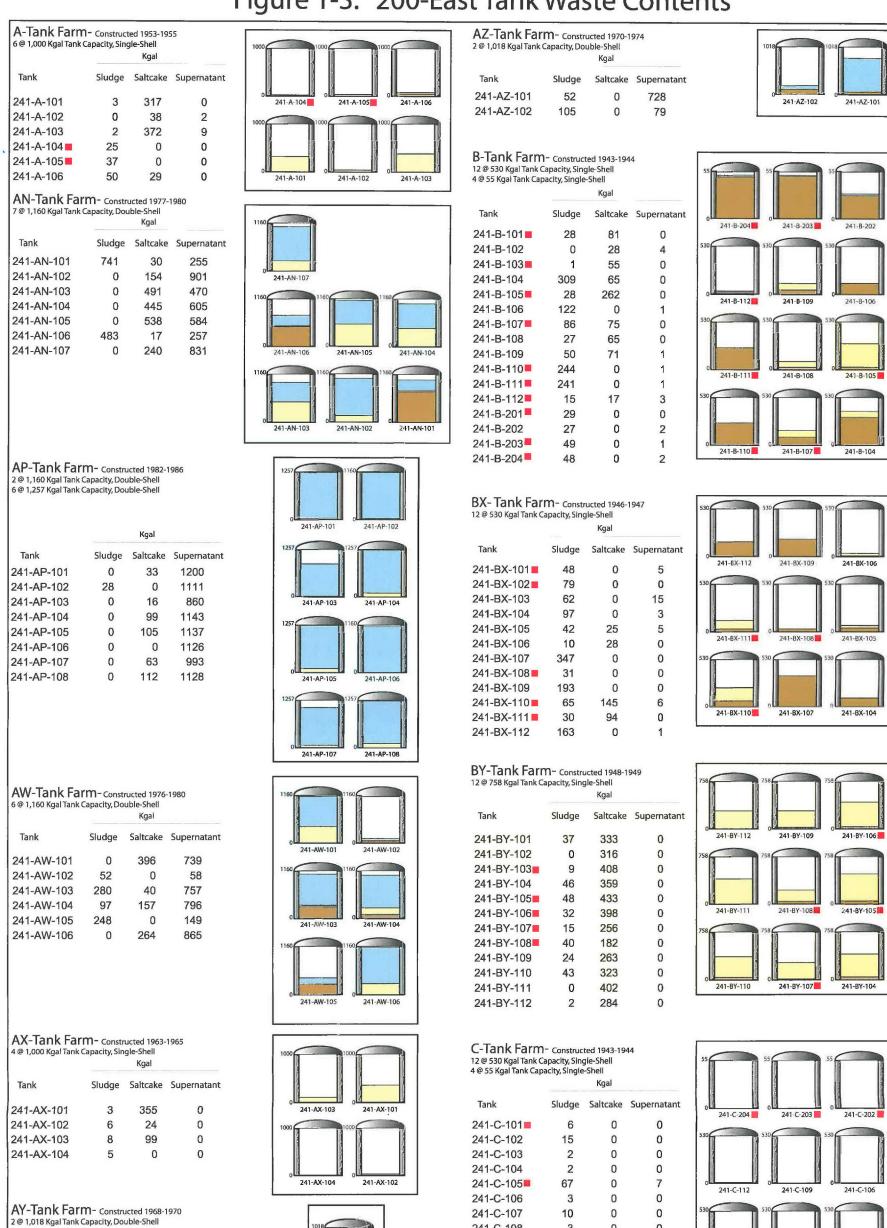
Figure 1-3. 200-East Tank Waste Contents

M. J. Rodgers **LEGEND** Sludge Saltcake Supernatant Available Space Assumed/Confirmed Leaker Data Derived From Waste Tank Summary Report Dated 1/31/2016
